BS 8458:2015: Annex C

Method for Measuring the Capability of a Watermist System to Control a Fire – “Room Fire Test for Watermist Systems with Automatic Nozzles”

A Report To: Plumis

Document Reference: 396489

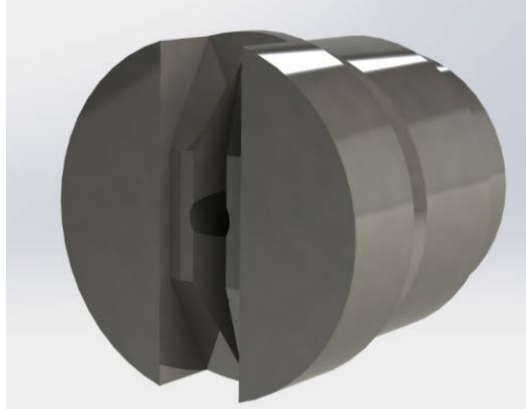
General description		Automist multiroom “Smartsan” targeted water mist fire suppression system
System reference		“Automist Multiroom Smartsan (“Hydra”) System”
Name of manufacturer		Plumis
Detailed description		Automist pre-engineered active targeted, single nozzle, multiroom, watermist fire suppression system
Nozzle	Product reference	“Smartsan vertical flat 65° spray nozzle part of SH11 spray head assembly”
	General description	Flat cone 65° 316SS single nozzle with M10x1 thread, 0.62 K factor.
	Name of manufacturer	Plumis supply chain
	Angle	65° flat cone
	Nozzle positions	Vertical, pointing to fire location
	Colour reference	“316 stainless steel” “Silver” (observed by Exova Warringtonfire)
	Photograph

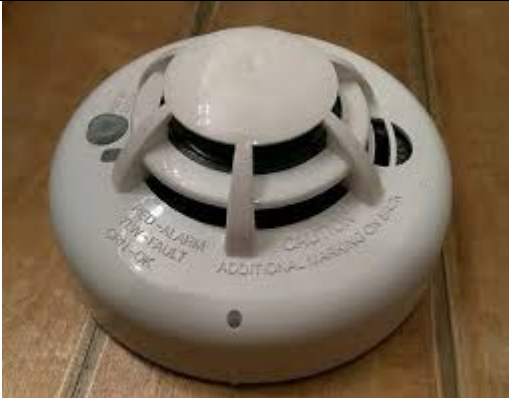
Heat alarm	Product reference	"51000"
	General description	Multi-criteria optical smoke + heat wireless Apollo alarm
	Name of manufacturer	Apollo
	Colour reference	"White"
	Photograph

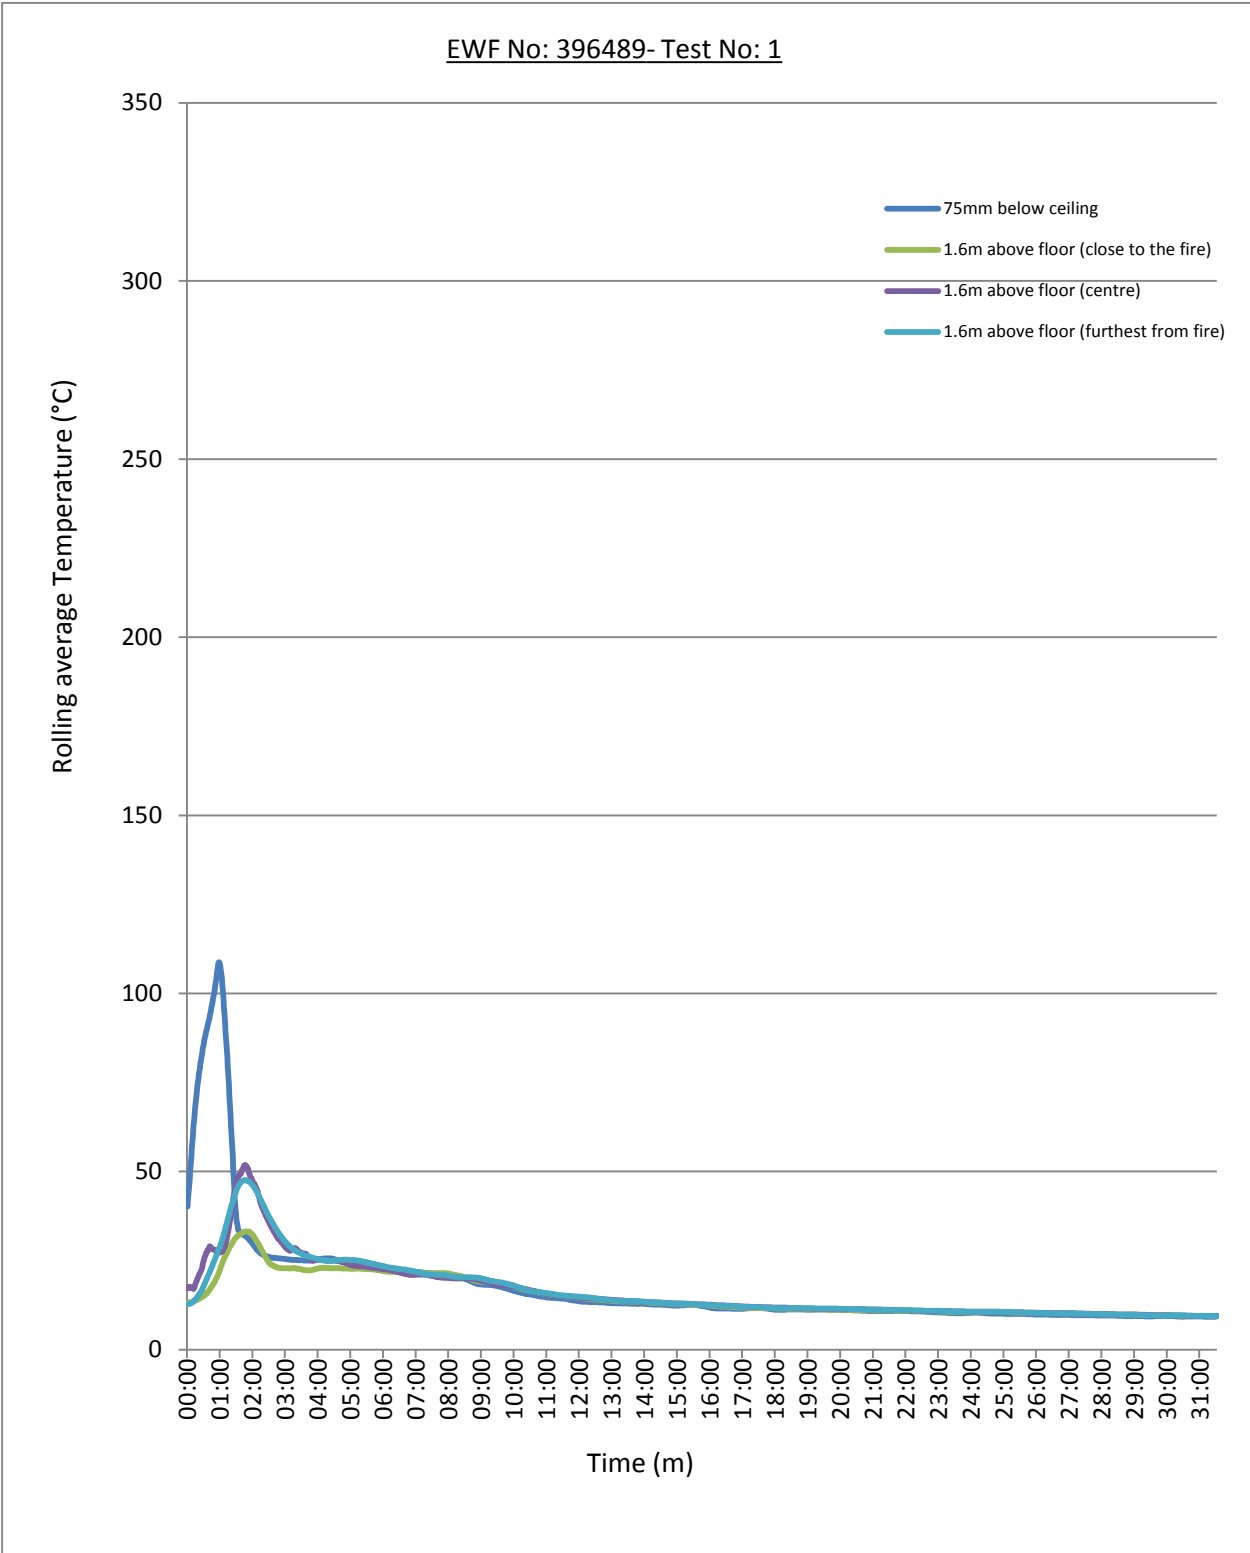
Figure 1

The rolling average temperatures logged during the tests are presented in Figures 1, 2, 3, 4, 5, 6, 7, 8, 9, 10 and 11.

The watermist system suppressed the test fires for a discharge duration of 10 minutes for domestic premises, measured from nozzle operation, during tests 1, 2, 3, 4, 5, 6, 7, 8, 9, 10 & 11 (See Figures 1, 2, 3, 4, 5, 6, 7, 8, 9, 10 and 11)

Within 2 minutes from the operation of the first nozzle, the mean recorded temperatures 75mm below the underside of the ceiling decreased and remained steady during tests 1, 2, 3, 4, 5, 6, 7, 8, 9, 10 & 11 (See Figures 1, 2, 3, 4, 5, 6, 7, 8, 9, 10 and 11)

From the start of the test, the recorded temperatures did not exceed the values indicated in BS 8458:2015: Table 2 for domestic premises, during tests 1, 2, 3, 4, 5, 6, 7, 8, 9, 10 & 11 (See Figures 1, 2, 3, 4, 5, 6, 7, 8, 9, 10 and 11)

Observations during test of Test 1

00:01 Test start, the fire loads were ignited.
00:39 Heat alarm sounded. Nozzle began to scan room.
01:24 Nozzle 2 activated.
31:24 Test terminated.

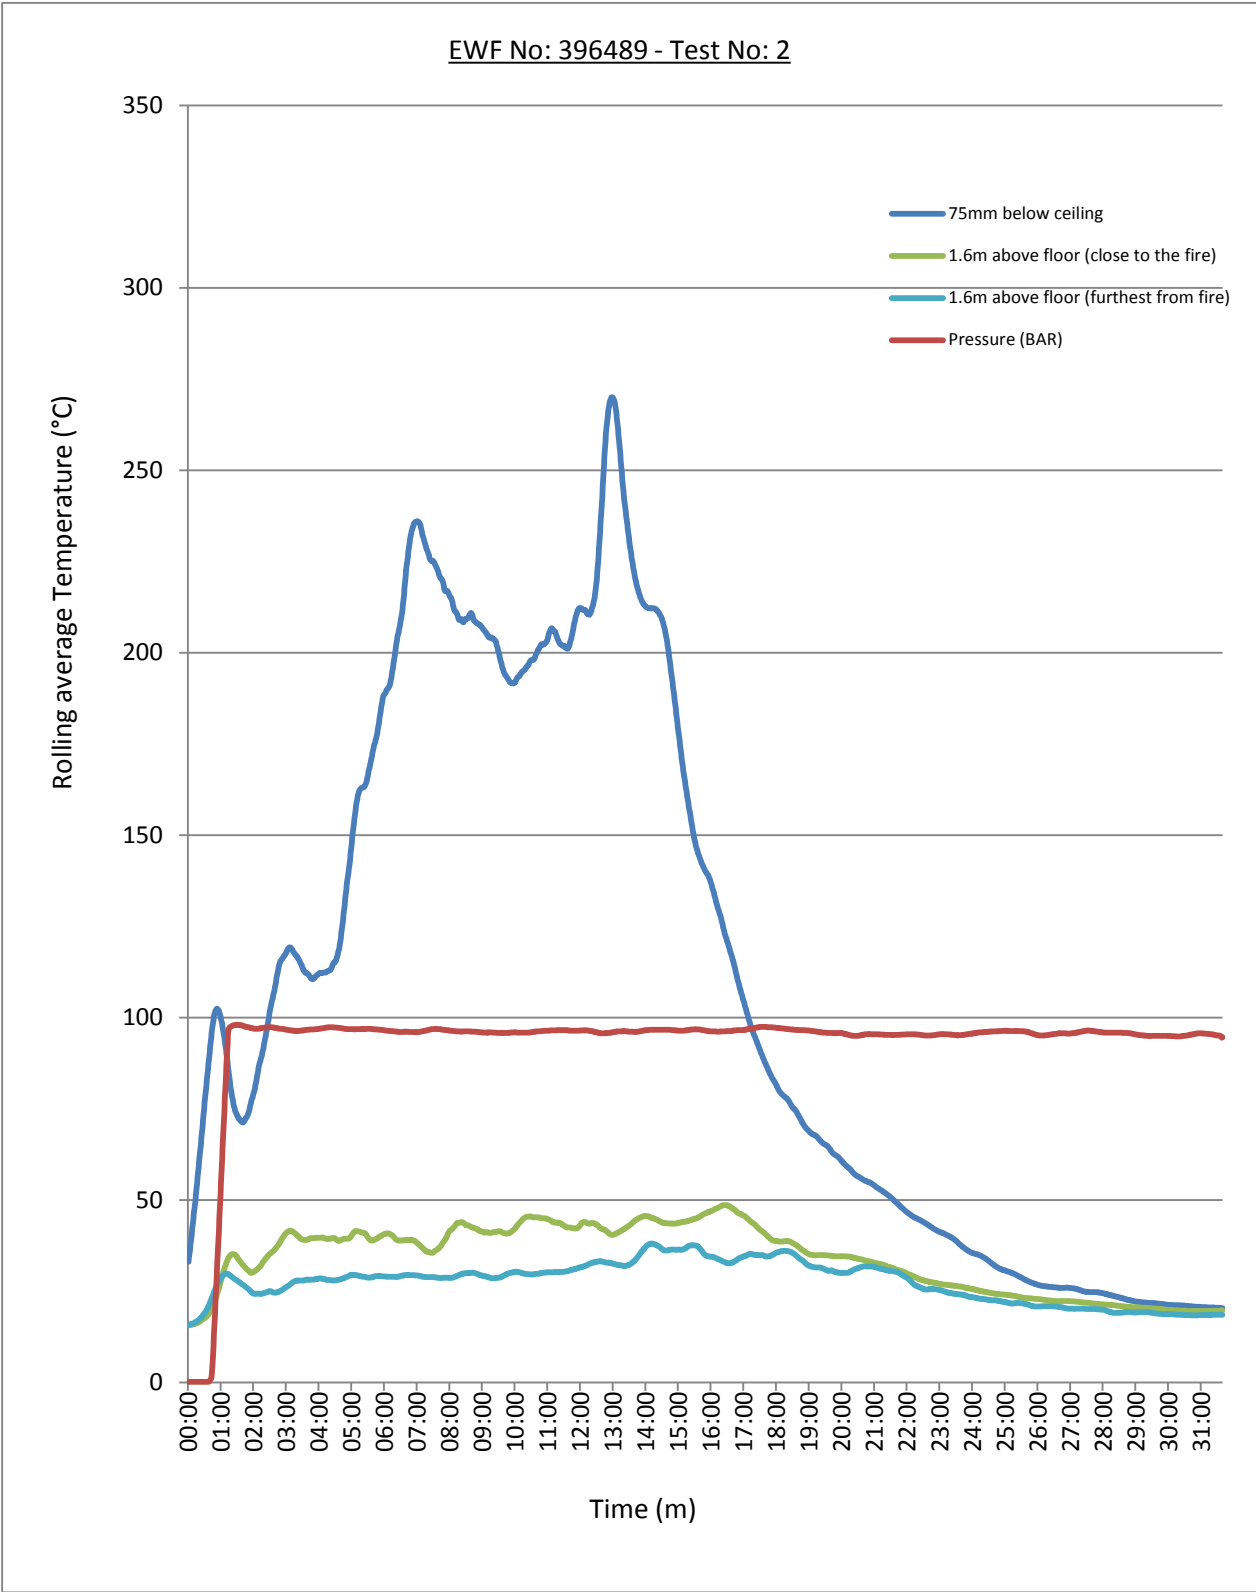
Figure 2

Operating pressure at pump	<p>The systems operating pressure was approximately 105 bar. The operating pressures throughout the tests are presented in Figures 2, 3, 4, 5, 6, 7, 8, 9, 10 and 11.</p>
Water flow rate	<p>The systems water flow rate at operation was 6l/min.</p>
Detection/actuation method	<p>The system utilised heat alarm detection that automatically activated the system on detection of the fire.</p>

Observations during test of Test 2

00:01 Test start, the fire loads were ignited.
00:31 Heat alarm sounded. Nozzle began to scan room.
01:08 Nozzle 1 activated.
31:08 Test terminated.

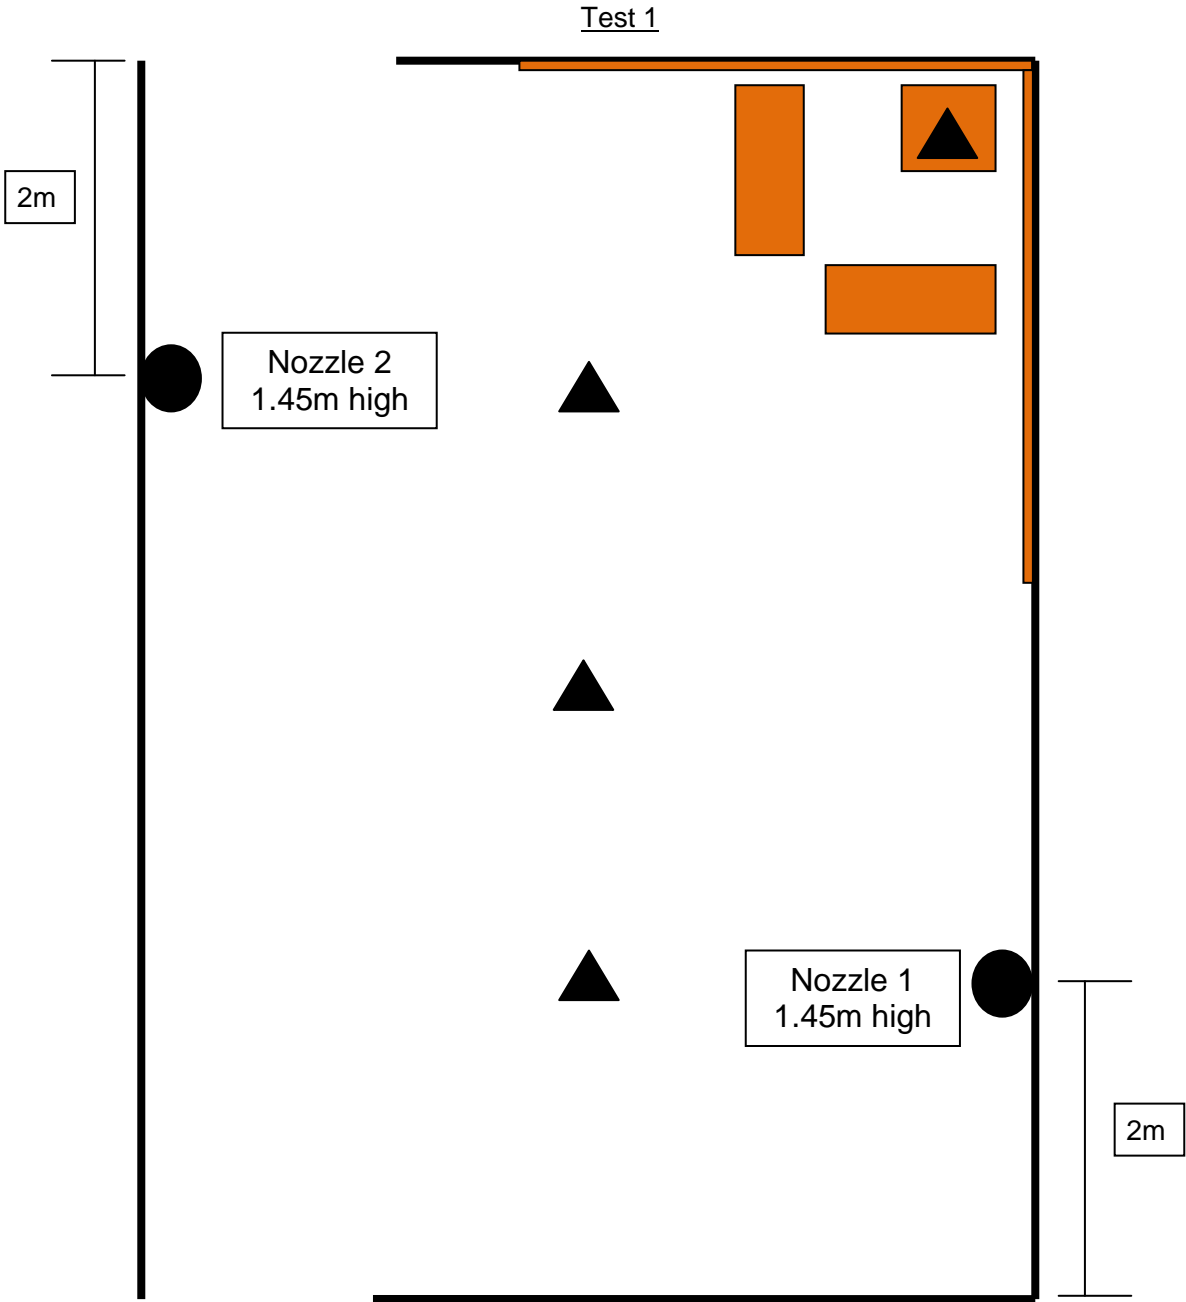
Figure 12

Corner, ignition and fuel package

Note 1: Nozzle measurements are the same for Figures 12, 13, 14 & 15

Nozzle configuration 1 (as detailed in Figures 12, 13, 14 and 15):

- Test 1 – Corner.
- Test 2 – Between two nozzles.
- Test 3 – Beneath a nozzle.
- Test 4 – Between two nozzles ventilation test.

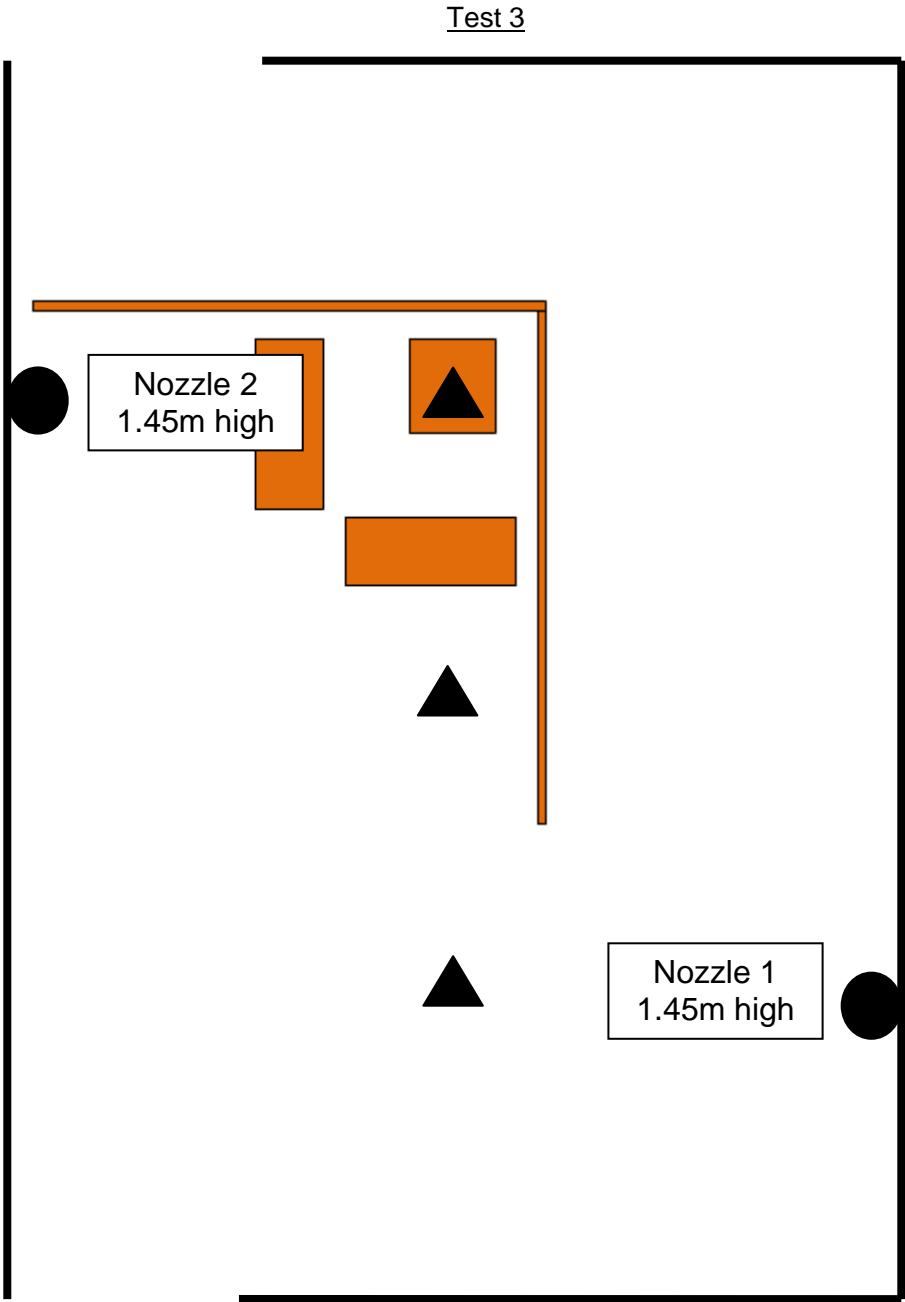
Figure 14

Beneath a nozzle ignition and fuel package

Nozzle
Note 1: Nozzle measurements are the same for Figures 12, 13, 14 & 15

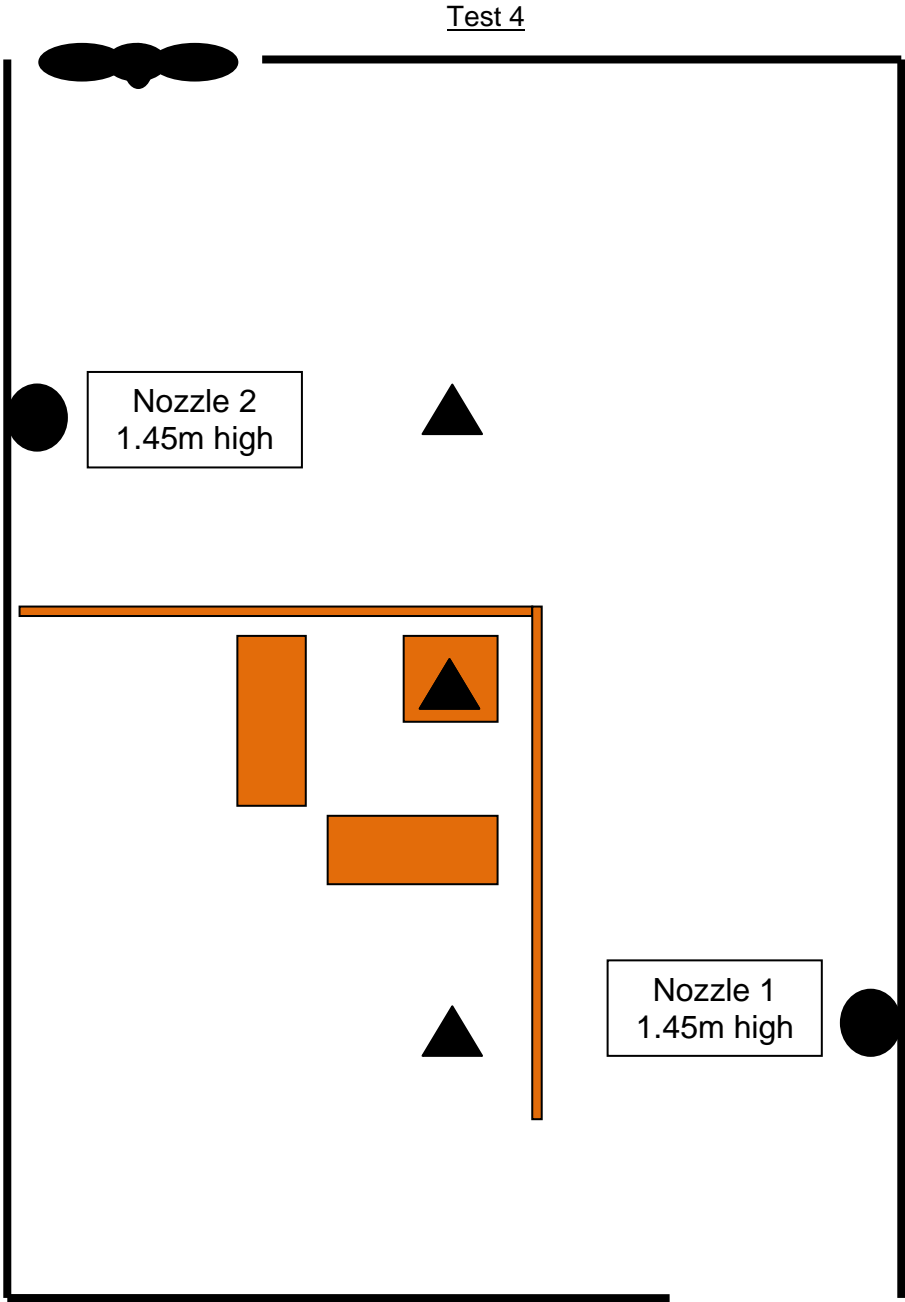
Figure 15

Between two nozzles ignition and fuel package

Note 1: Nozzle measurements are the same for Figures 12, 13, 14 & 15

Fan

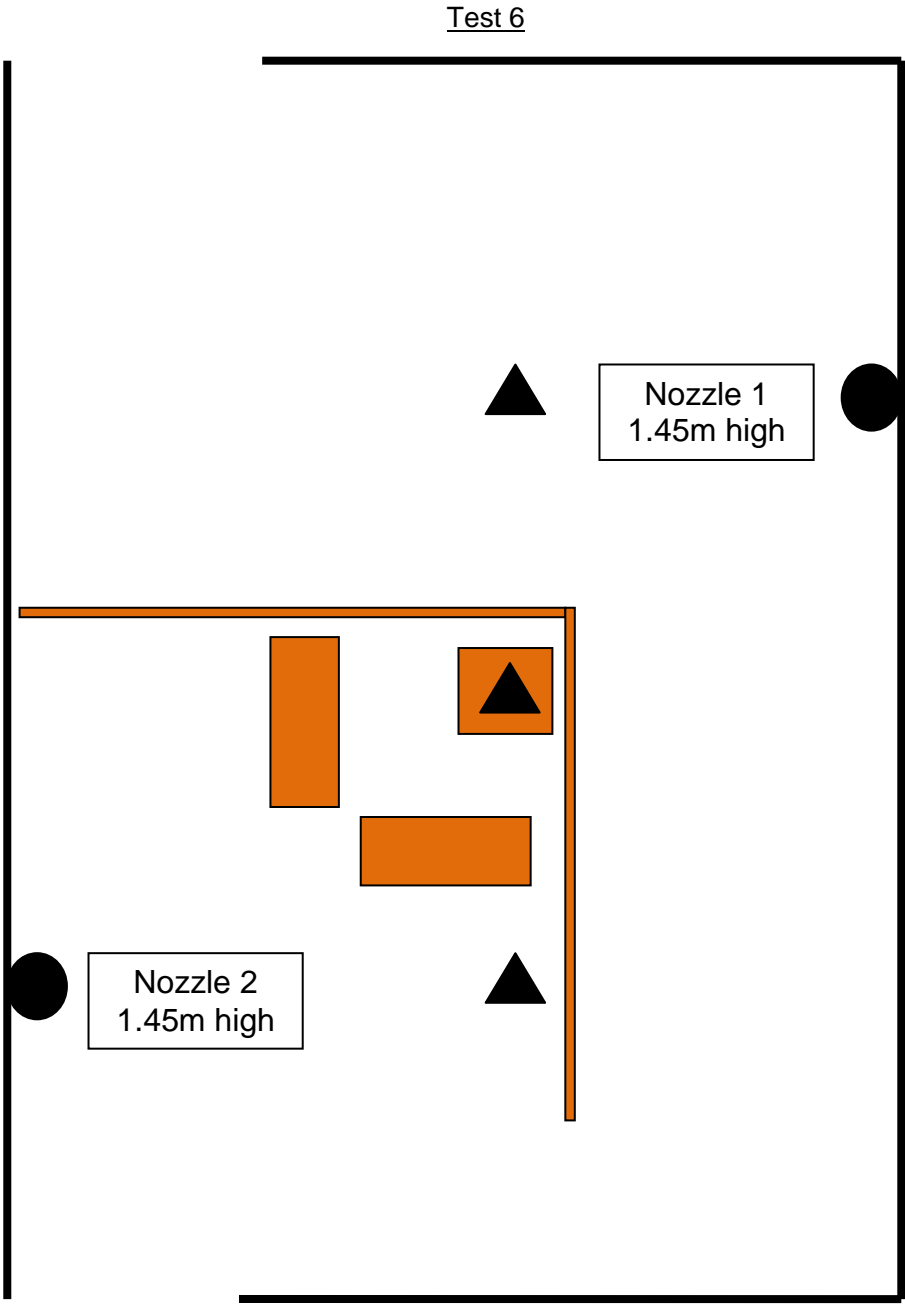
Figure 17

Between two nozzles ignition and fuel package

Nozzle
Note 1: Nozzle measurements are the same for Figures 16, 17, 18 & 19

Nozzle configuration 2 (as detailed in Figures 16, 17, 18 and 19):

- Test 5 – Corner.
- Test 6 – Between two nozzles open room test.
- Test 7 – Beneath a nozzle open room test.
- Test 8 – Corner ventilation test.

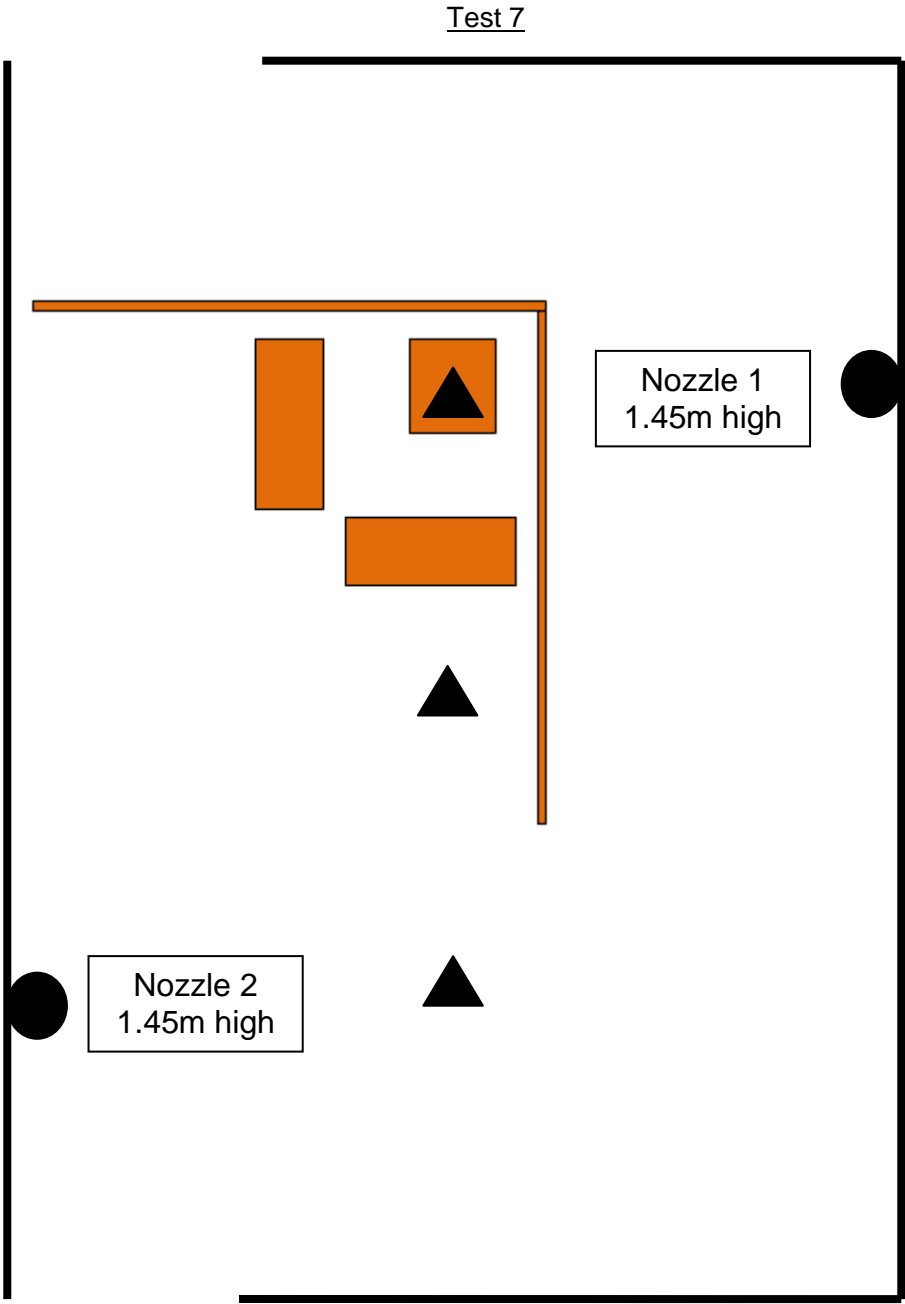
Figure 18

Beneath a nozzle ignition and fuel package

Nozzle
Note 1: Nozzle measurements are the same for Figures 16, 17, 18 & 19

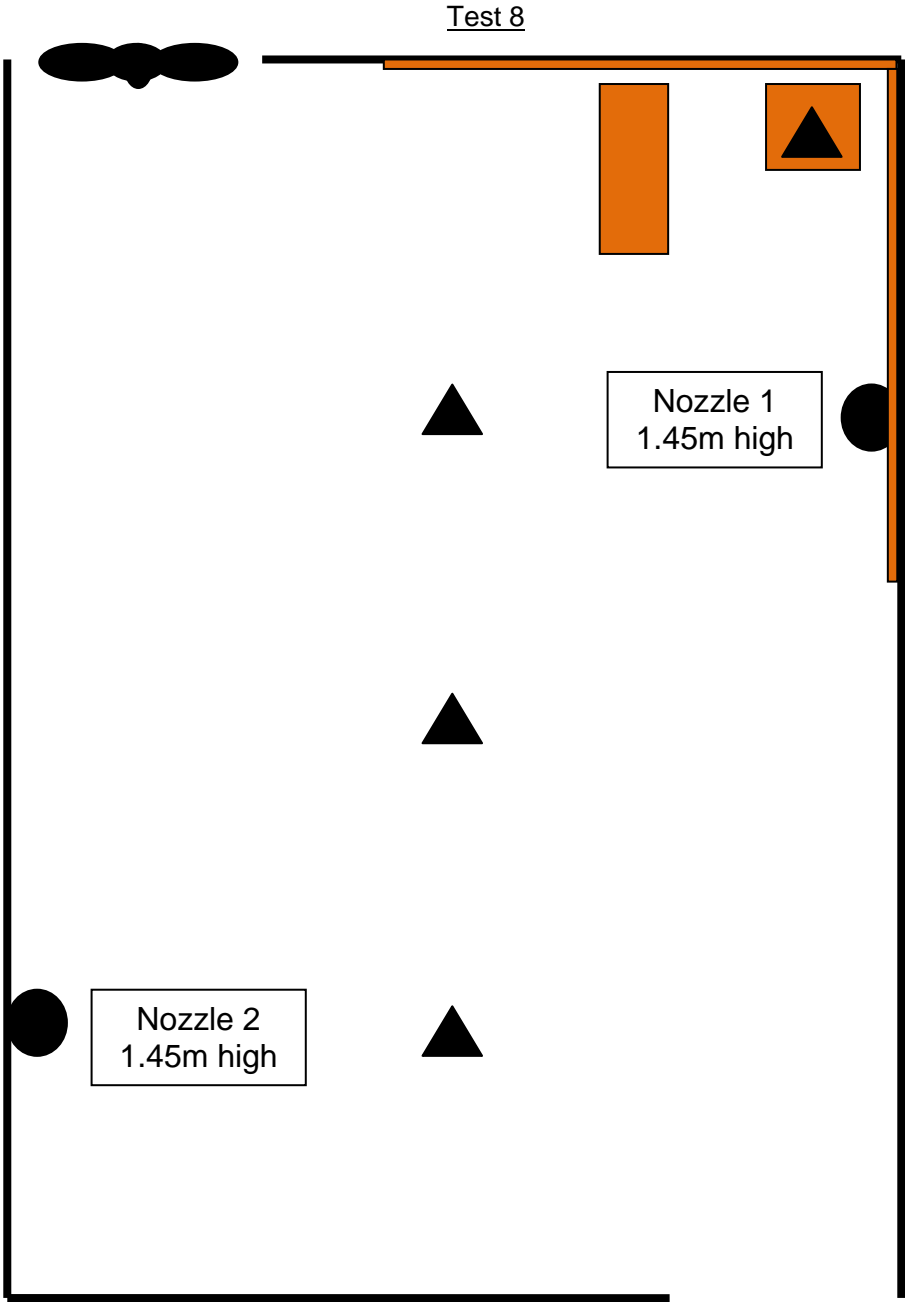
Figure 19

Corner ignition and fuel package

Nozzle
Note 1: Nozzle measurements are the same for Figures 16, 17, 18 & 19

Fan

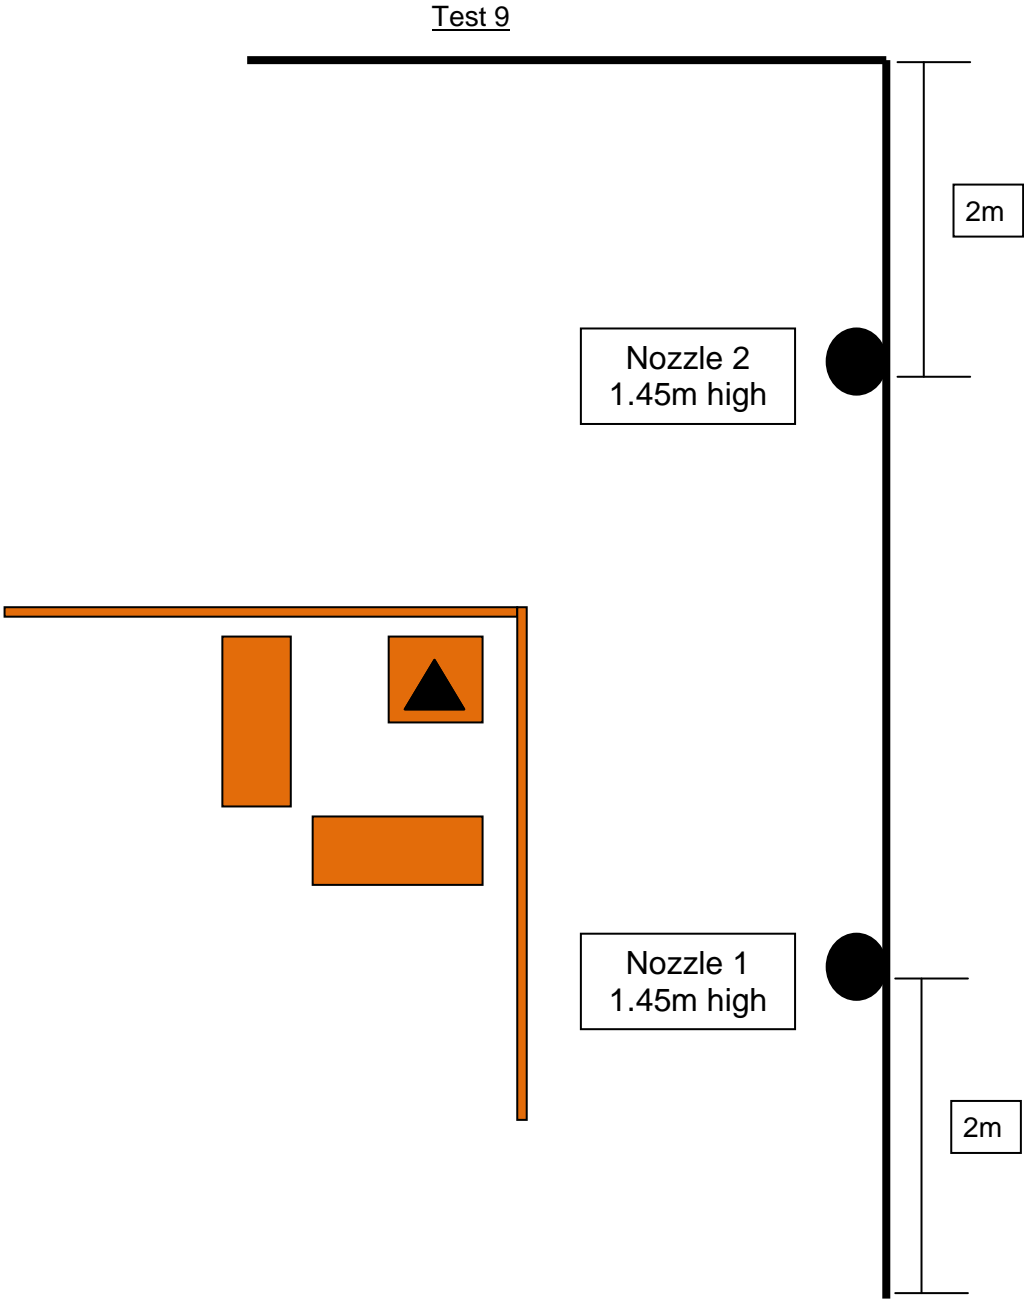
Figure 20

Between two nozzles ignition and fuel package

Nozzle
Note 1: Nozzle measurements are the same for Figures 20, 21 & 22

Nozzle configuration 3 (as detailed in Figures 20, 21, 22 and 23):

- Test 9 – Between two nozzles open room test.
- Test 10 – Beneath a nozzle open room test.
- Test 11 – Corner open room test.

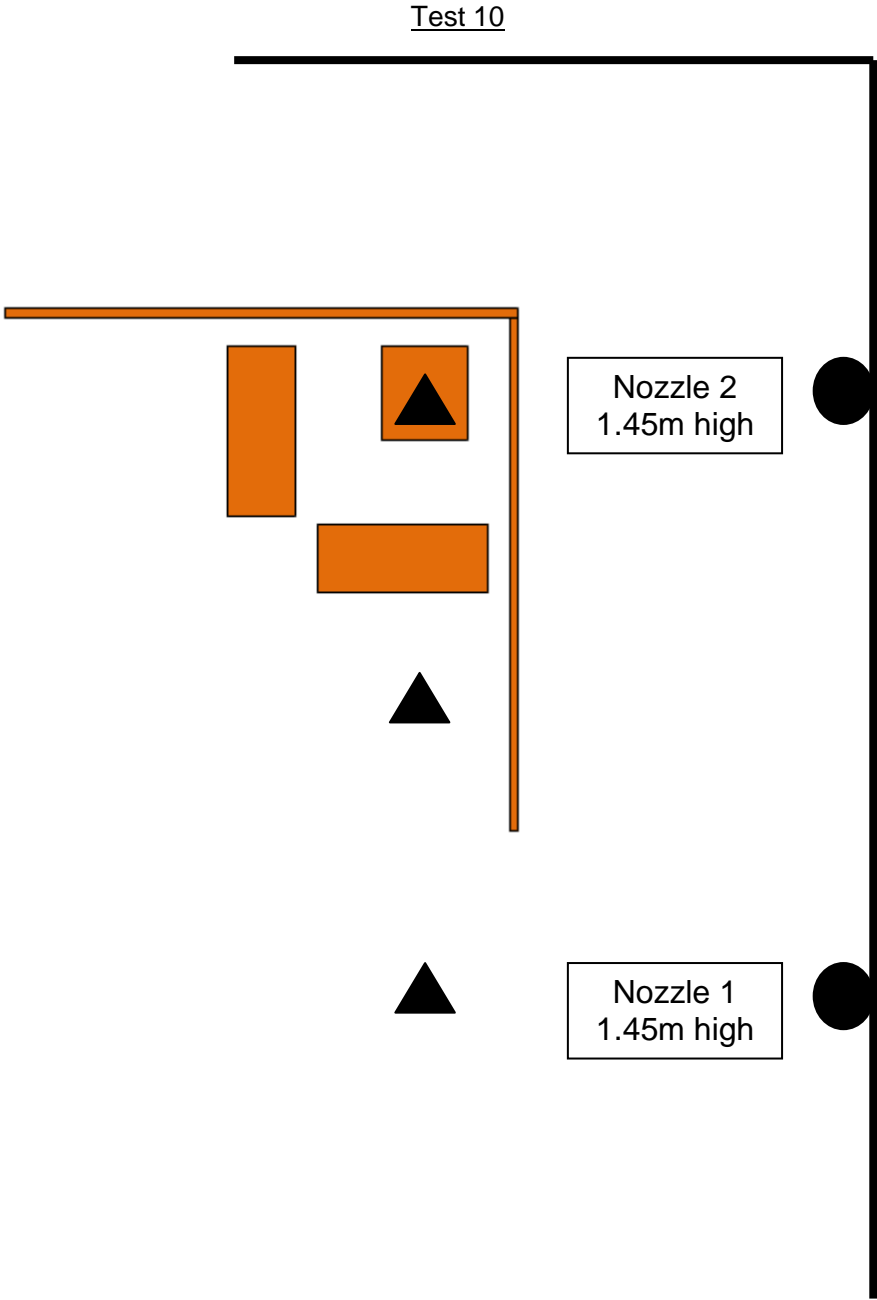
Figure 21

Beneath a nozzle ignition and fuel package

Nozzle
Note 1: Nozzle measurements are the same for Figures 20, 21 & 22

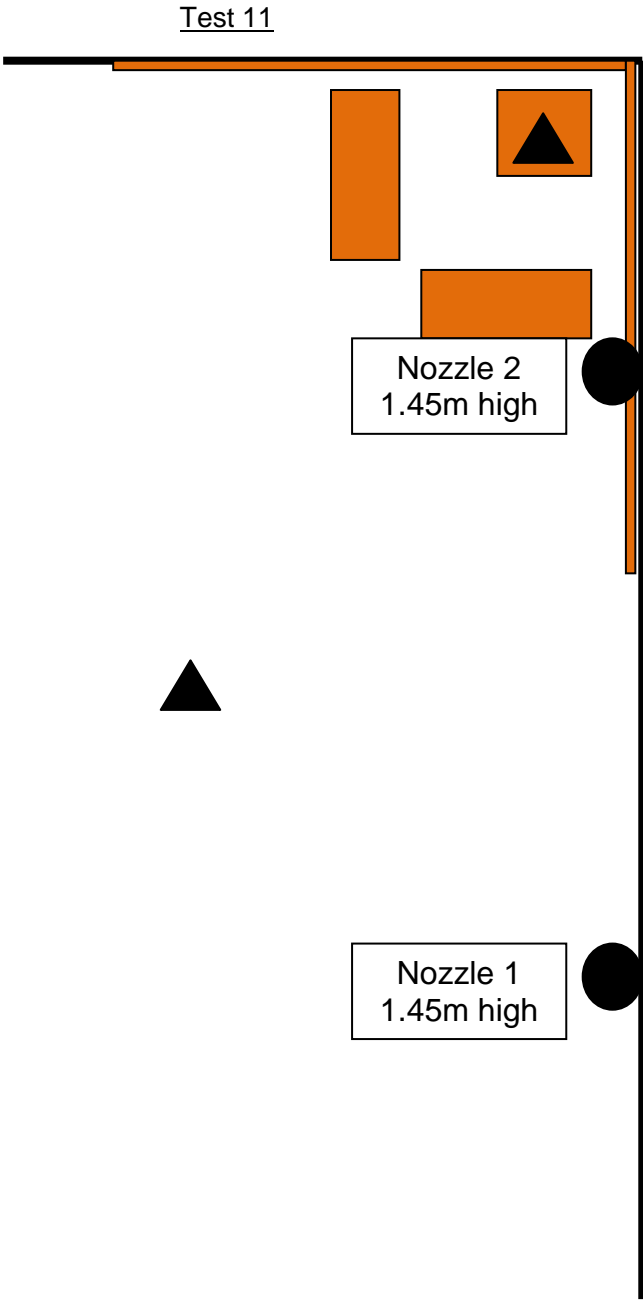
Figure 22

Corner, ignition and fuel package

Note 1: Nozzle measurements are the same for Figures 20, 21 & 22

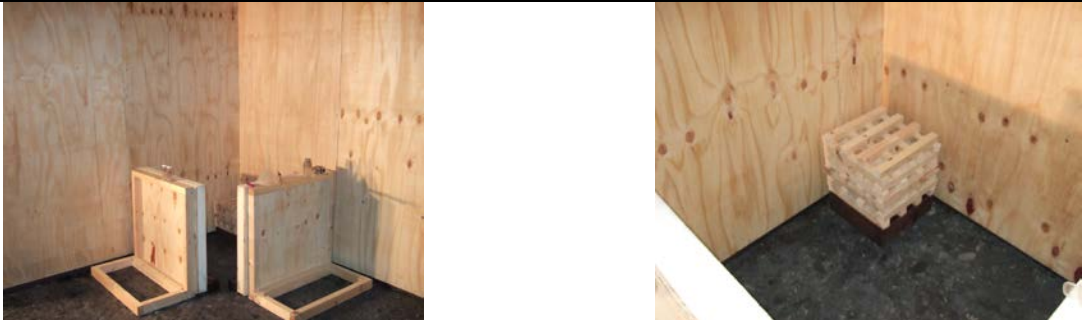
Photographs of ignition and fuel package before a test

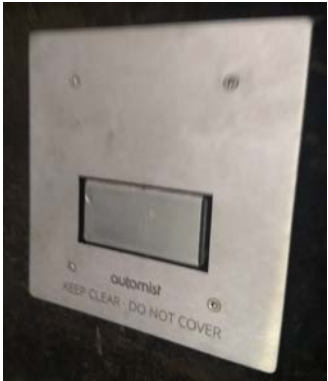
Photograph of nozzle system before a test

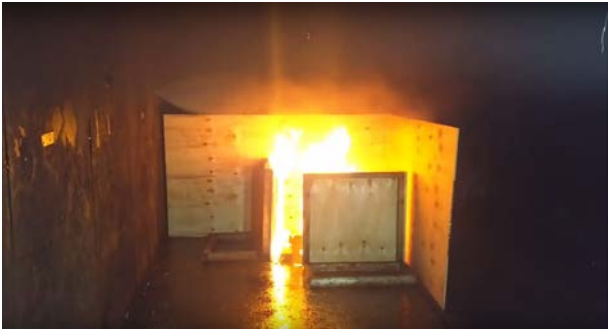
Photograph during a test

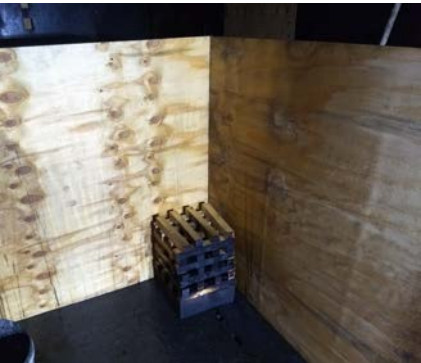
Photograph after a test
